NORTH RESERVOIR DAM  
MA 00457

PHASE I INSPECTION REPORT  
NATIONAL DAM INSPECTION PROGRAM

DEPARTMENT OF THE ARMY  
NEW ENGLAND DIVISION, CORPS OF ENGINEERS  
WALTHAM, MASS. 02154

FEBRUARY 1979

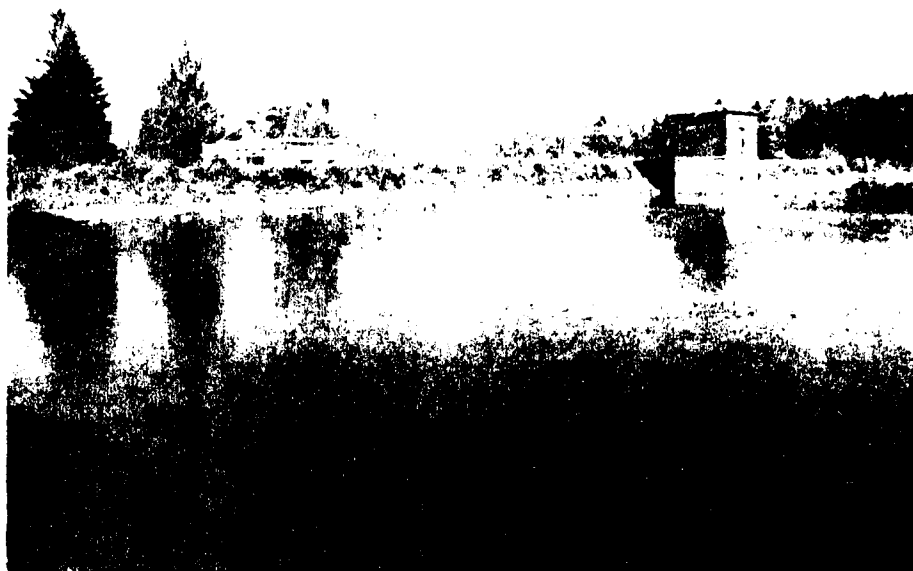
3. Riprap consisting of 12 to 18-in. stones and present along the upstream face below approx. El. 147, is locally dislodged, Photos No. 2 and 3.
4. It is reported that animal burrows were found in the embankment in the past and that attempts were made to exterminate the animals. However, no evidence of animal burrows was noted during the site visit. The unmowed grass on the downstream slope impeded close examination.

2. Upstream face of embankment viewed from near left abutment

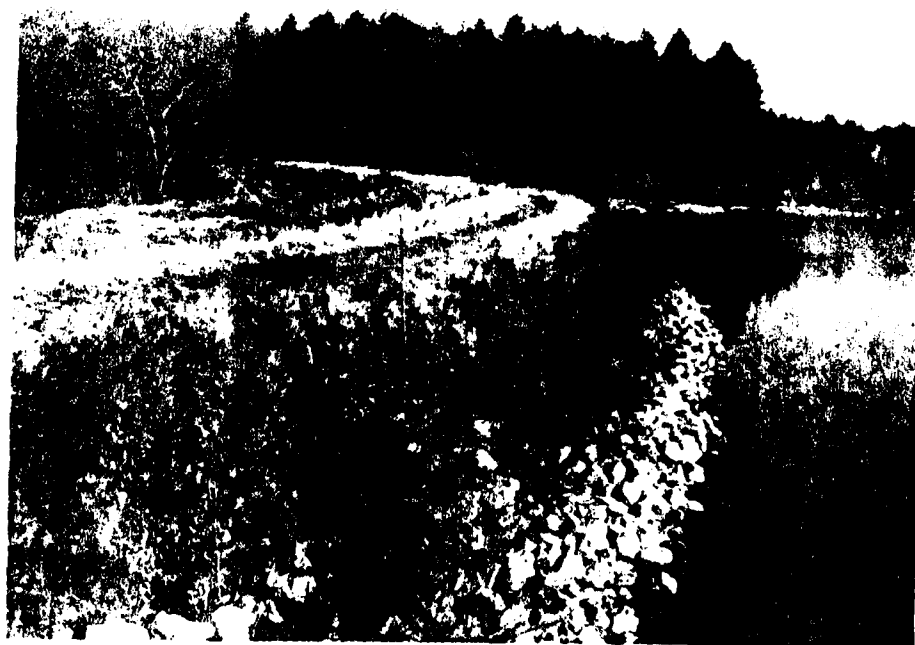
1. The embankment crest has an earth and stone-dust roadway which shows slight wear by vehicle traffic, Photos No. 3 and 4.
2. The embankment slopes are mostly grass covered with some brush and small saplings, Photos No. 1, 3 and 4. Some localized erosion was noted on the upstream face near the crest.

3. Upstream face of embankment viewed from gate-house

6. Remove or replace the spillway stoplogs.
7. Repair localized erosion on upstream face of dam near crest.

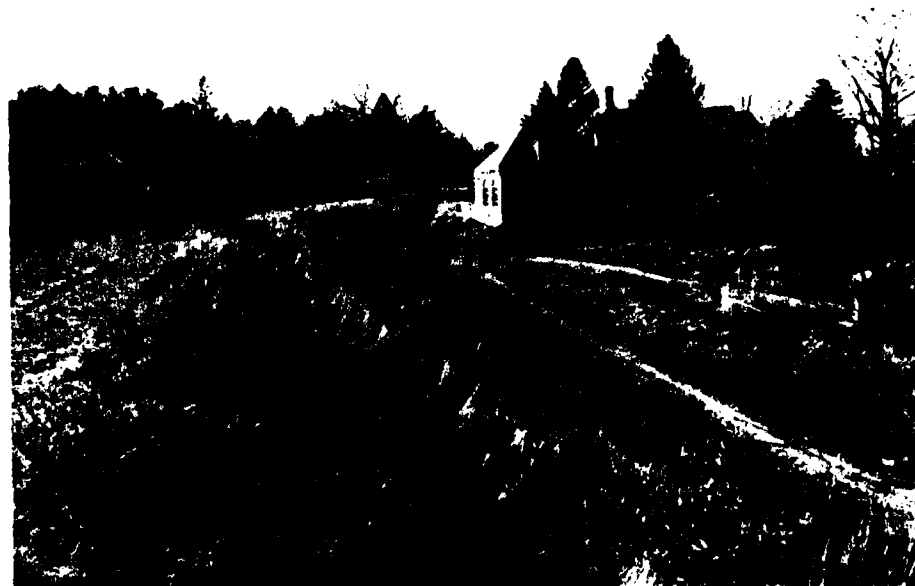
4. Downstream face of embankment

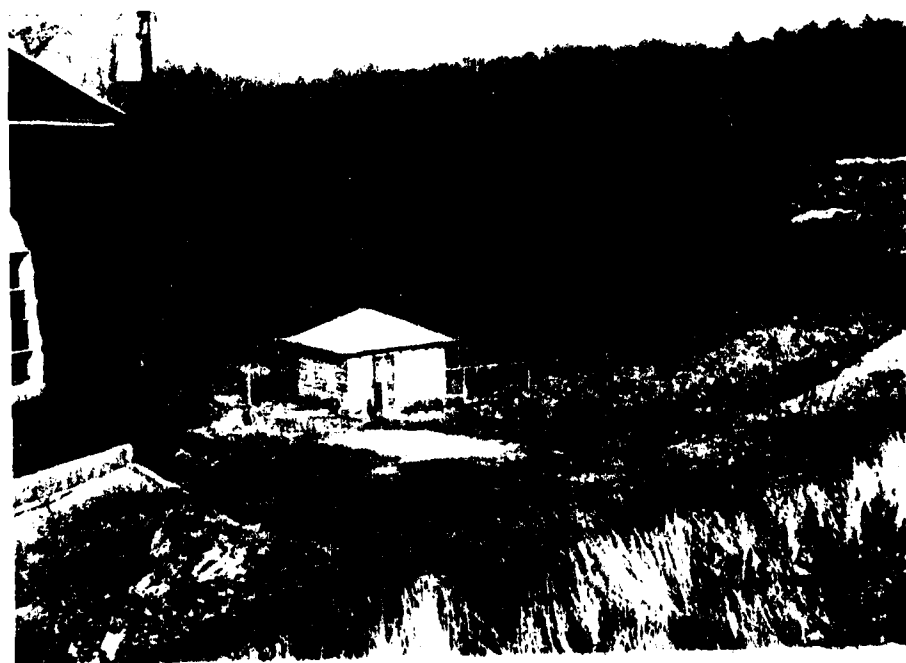
5. Chlorination Station

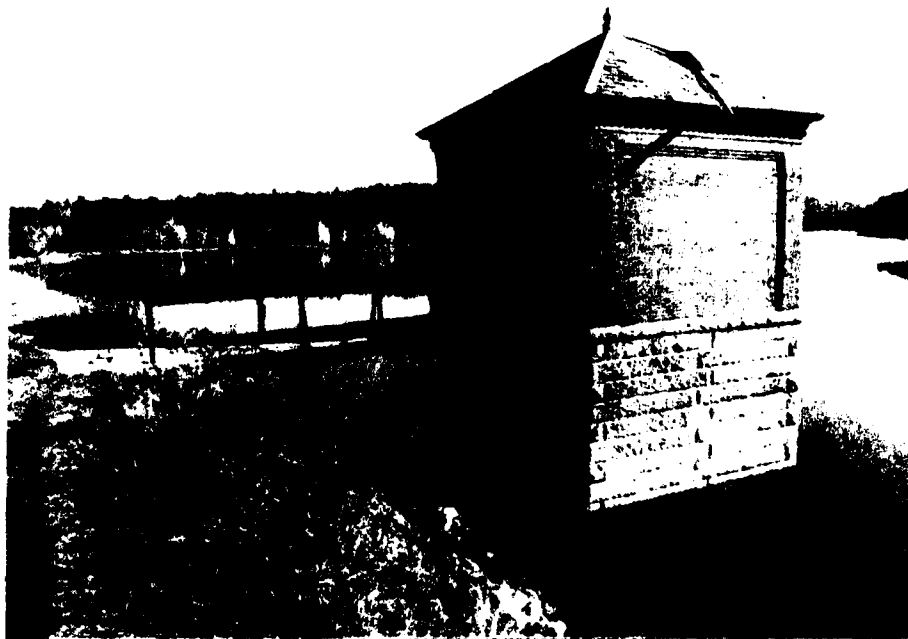
The gatehouse is a mortared stone masonry and brick structure with a slate covered roof, Photo No. 6. A steel pedestrian bridge provides access to the gatehouse. The bridge appears to be well maintained and in good condition, but minor rusting is taking place. Copper flashing on the gatehouse roof is in need of repair.

6. Gatehouse

3. All brush, trees and other obstructions should be cleared from the spillway channel. The channel should be cleared at least once each year.
4. Copper roof flashing on the gatehouse should be repaired and the access bridge steel should be cleaned and painted.
